Sample Thermal Imaging Report

Measuring Date: 26/11/2010

Task	This is a sample report for a thermal imaging survey done to identify areas of heat loss for a property in Gloucestershire
-------------	--

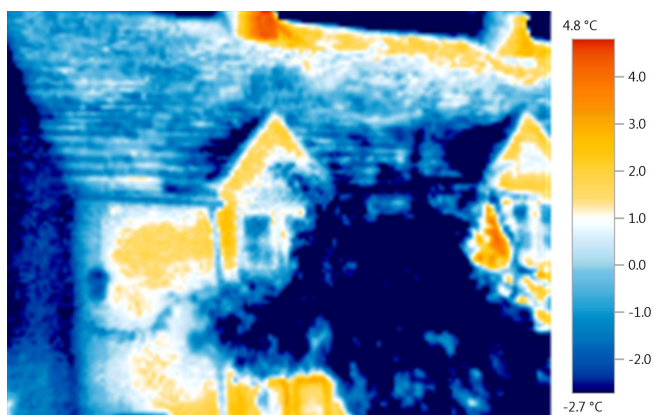
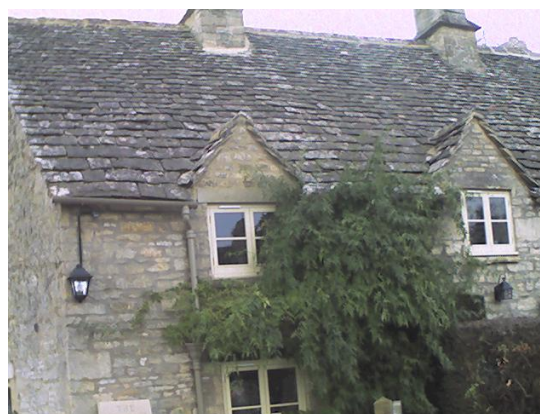
File:
IV_00037.BMT

This first image of the property has highlighted the following issues:

- Heat leaking out of the top of the roof.
- Heat leaking out of the top of the dormer windows.
- Heat leaking out of the windows.

Once the issues have been identified then it is possible to address the areas of concern.

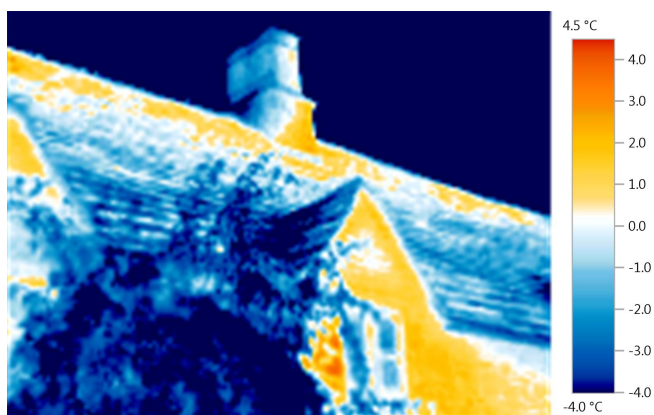
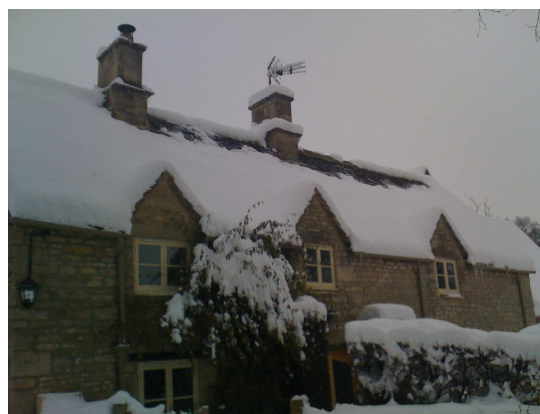
File:
IV_00052.BMT

This thermal image shows where heat is leaking out of the roof where the property is poorly insulated.

The photo associated with this image was taken later in the year after a heavy snowfall and it can clearly be seen where the escaping heat has melted the snow on the roof.

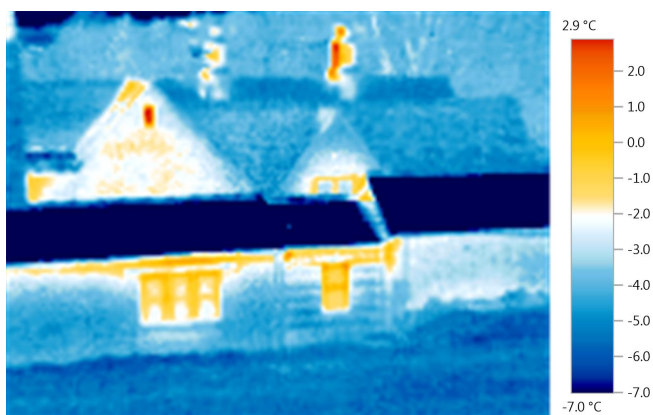
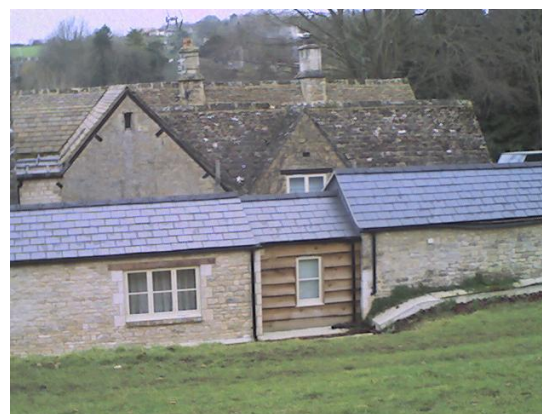
File:
IV_00051.BMT

This thermal image has highlighted various issues with this property.

Heat can be seen to be leaking out from all the windows in this property. This indicates that the windows have been poorly fitted and have not been sealed properly. The part of the property at the front of the photo is also missing insulation as can be seen by the long horizontal strips or orange where heat is leaking out of the property underneath the eaves. Now the problems have been identified it is possible to rectify the issues.

It is interesting to see that the chimney on the right of the property is showing as very hot as there is a wood burning stove lit in the property.

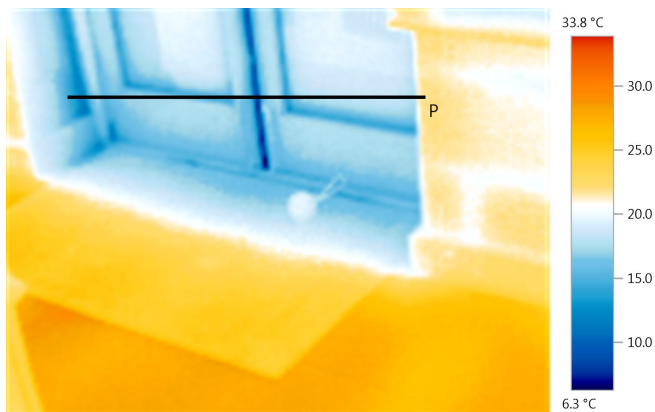
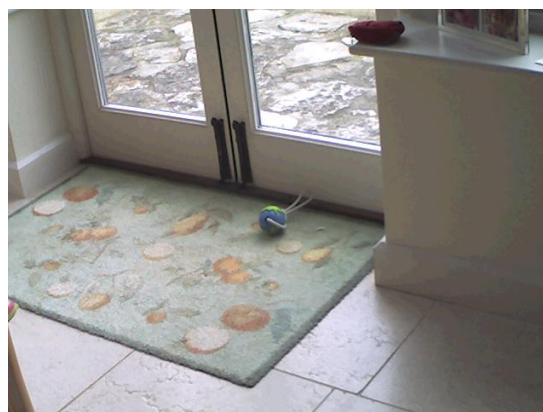
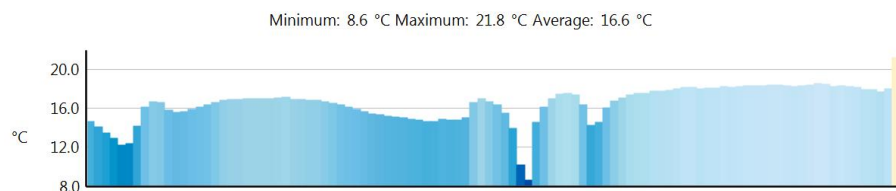
File:
IV_00055.BMT

The floor in this thermal image is showing as orange as there is underfloor heating in this room.

A temperature profile has been taken across these doors and is displayed on the graph. The temperature profile shows that there is a large amount of heat leaking out between the doors and also around the edges of the doors.

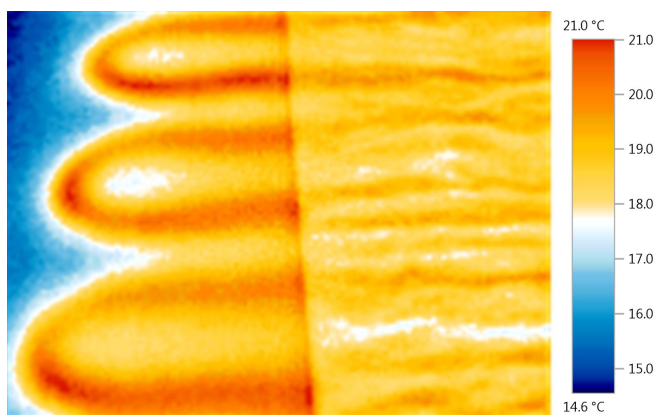
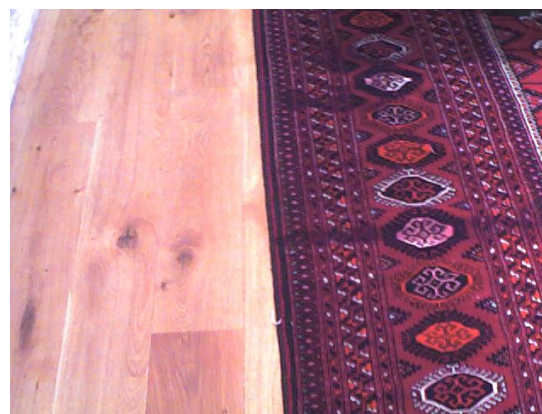
File:
IV_00097.BMT

This is a thermal image of an area of floor with a 'suspended' underfloor heating.

The thermal imaging camera allows us to see through the floor boards and if there was a blockage in the underfloor heating pipework then we would be able to identify where this is and rectify the problem.

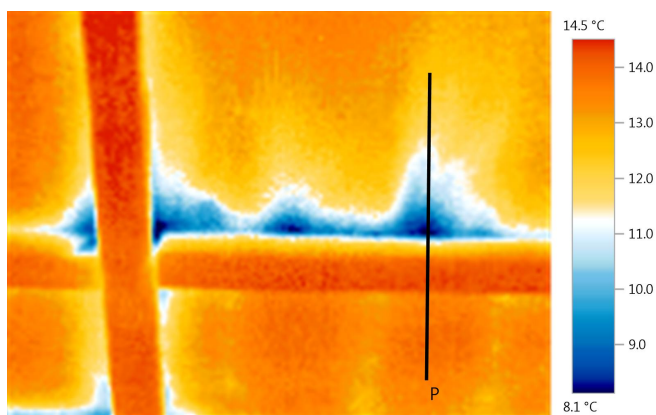
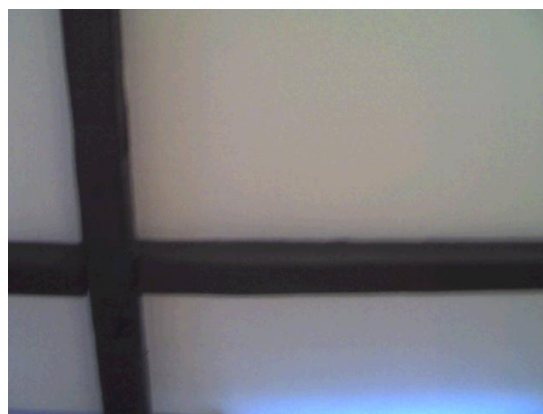
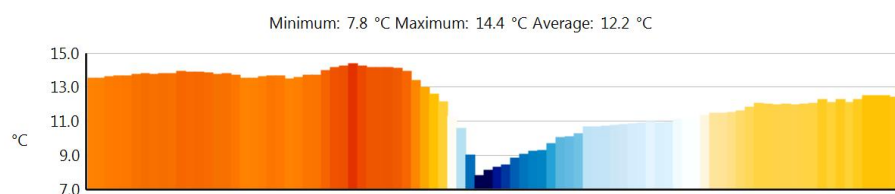
File:
IV_00079.BMT

this thermal image has been taken of a beam in a sloping ceiling.

This blue areas of this image show that these areas of the ceiling poorly insulated as there is significant heat loss.

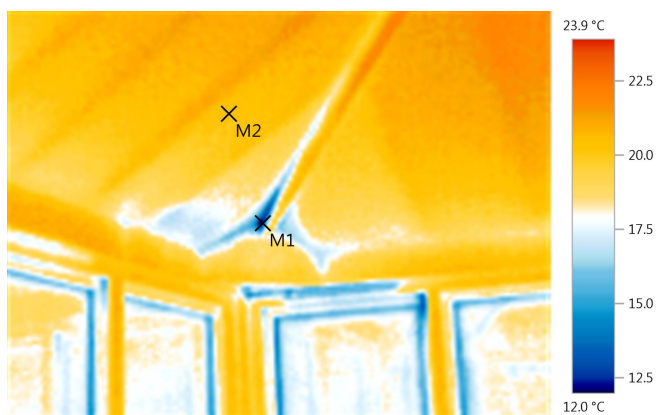
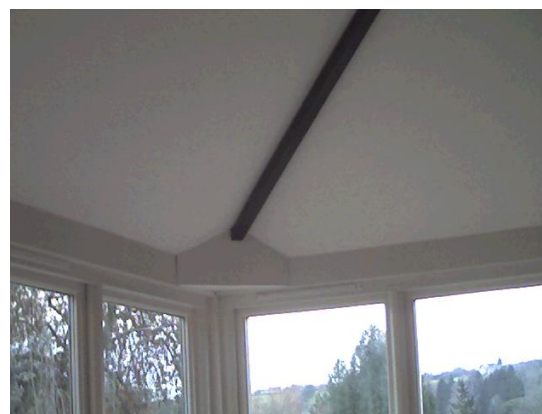
File:
IV_00108.BMT

Measurement Objects	Temp. [°C]	Emiss.	Refl. temp. [°C]	Remarks
Measure point 1	12.8	0.95	20.0	-
Measure point 2	20.2	0.95	20.0	-

This thermal image has identified an area of the ceiling where the property is poorly insulated.

There is a significant heat loss in the area marked M1 (compared with M2). The reporting software allows us to measure the temperature at any of the 19,500 points of the image, and as the thermal imaging camera saves the raw data for the image the temperature at any point can be interrogated once we have left the site.
